AVIATION INVESTIGATION REPORT

A01P0296

CESSNA 152 C-GJKE

BOUNDARY BAY AIRPORT, BRITISH COLUMBIA

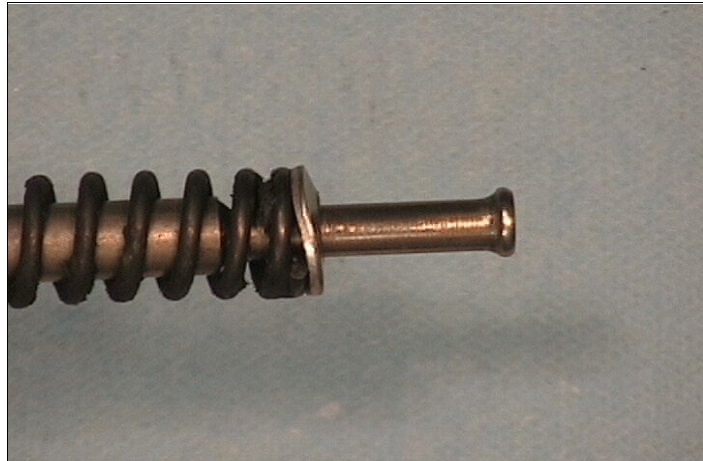
Figure 1 - Spring and bent spring retainer washer on the rod section of occurrence RH nosewheel steering tube assembly

It was noted that the RH assembly could not be extended against the internal spring pre-load pressure, an action necessary to apply right rudder when airborne with the nosewheel in the normal centred and locked position. Dissection of both nosewheel steering tube assemblies revealed that the inner spring retainer washer on the end of the rod section in the RH assembly was saucer shaped and positioned on the opposite side of an annular crimp in the outer tube section when compared to the same part in the LH assembly (see Figure 1). From this position, it could not return to its normal position and operation. If this condition pre-existed, it would not prevent steering action on the ground, yet it would mechanically prevent the application of right rudder when the nose oleo extended at lift-off and engaged the nosewheel centring and locking cam. The left rudder would operate normally since the RH nosewheel steering tube assembly could still operate in the compression mode. Furthermore, in this condition, the automatic centring action of the nose gear as the aircraft lifted off would have resulted in the application of two to four degrees of left rudder deflection. This is due to the left hand rudder centring spring taking up the slack introduced in the right hand rudder cable by the right hand rudder pedal being moved aft of its normal position due to the shortened length of the RH nosewheel steering tube assembly.

1. Even in the damaged condition as found, the washer in the RH nosewheel steering tube assembly withstood design loads during testing.
2. It could not be determined whether the anomaly in the RH nose gear steering tube assembly was the result of impact damage or whether the condition was pre-existing. If it was pre-existing, an explanation for the development of this anomaly could not be determined.

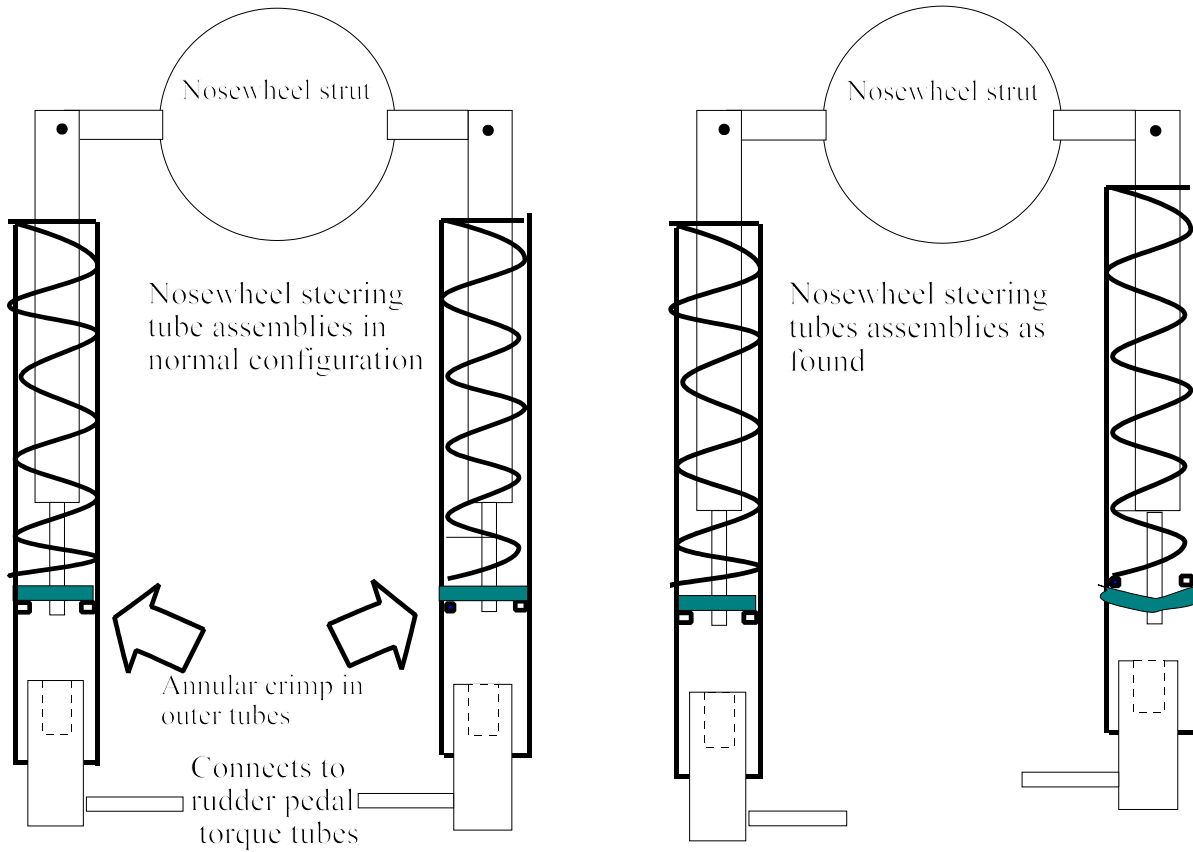
Appendix A

The aircraft is equipped with two nose gear steering tube assemblies, a right and a left. The purpose of these assemblies is to allow rudder operation to continue when the nosewheel centres and locks upon oleo extension at lift-off. These assemblies are similar in appearance to a shock absorber and incorporate a built-in, pre-load spring which operates when the unit is placed under tension. Each assembly connects the left or right rudder pedal torque tube to its respective side of the nose gear steering collar. Each rudder pedal torque tube is also connected aft to the rudder via cables, which form a closed loop system (Appendix A).
